ON-SITE AIR BAG INVESTIGATION

CASE NO. - 96-16
FLEET - PRIVATE VEHICLE
LOCATION -
ACCIDENT DATE -

TRC/IU CASE NO. 96-16

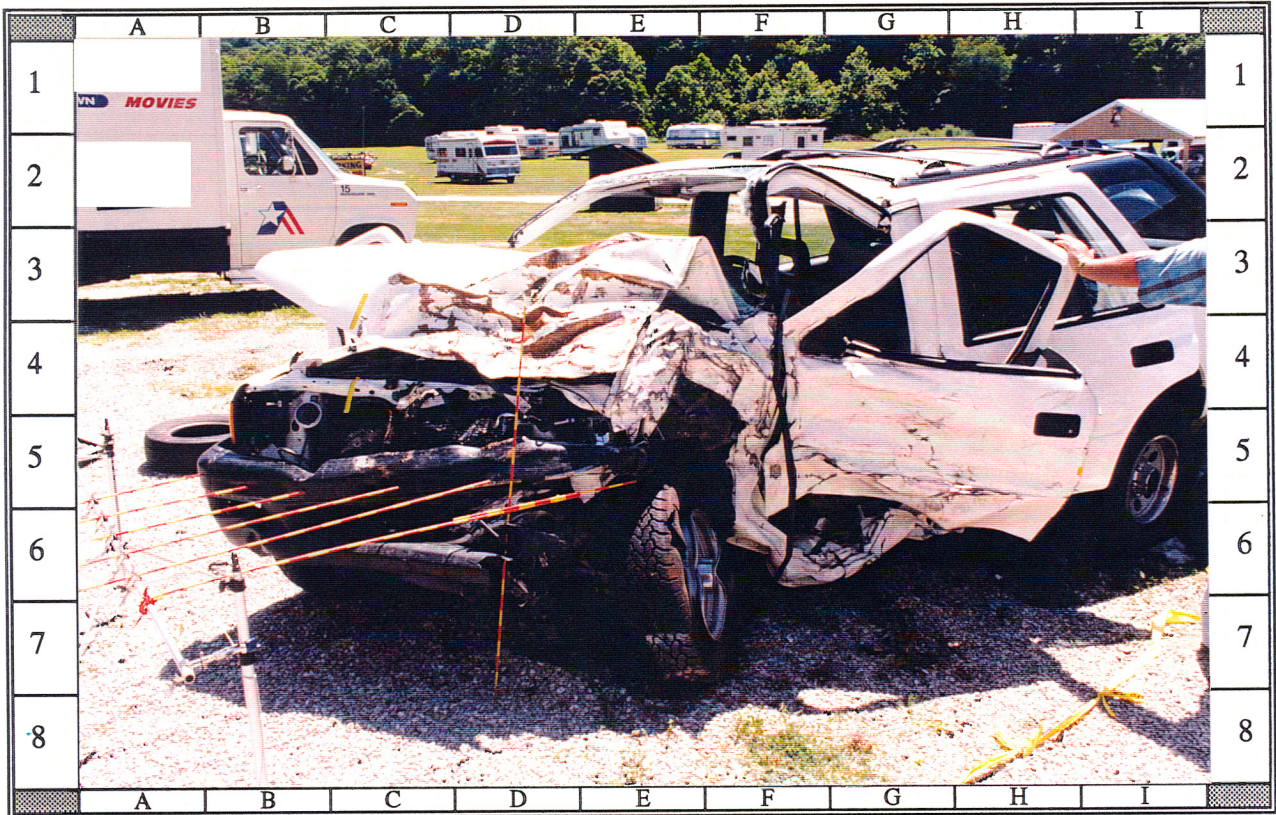
28: Case Vehicle's damaged front and left side viewed from approximately 30 degrees left of front with contour gauge present

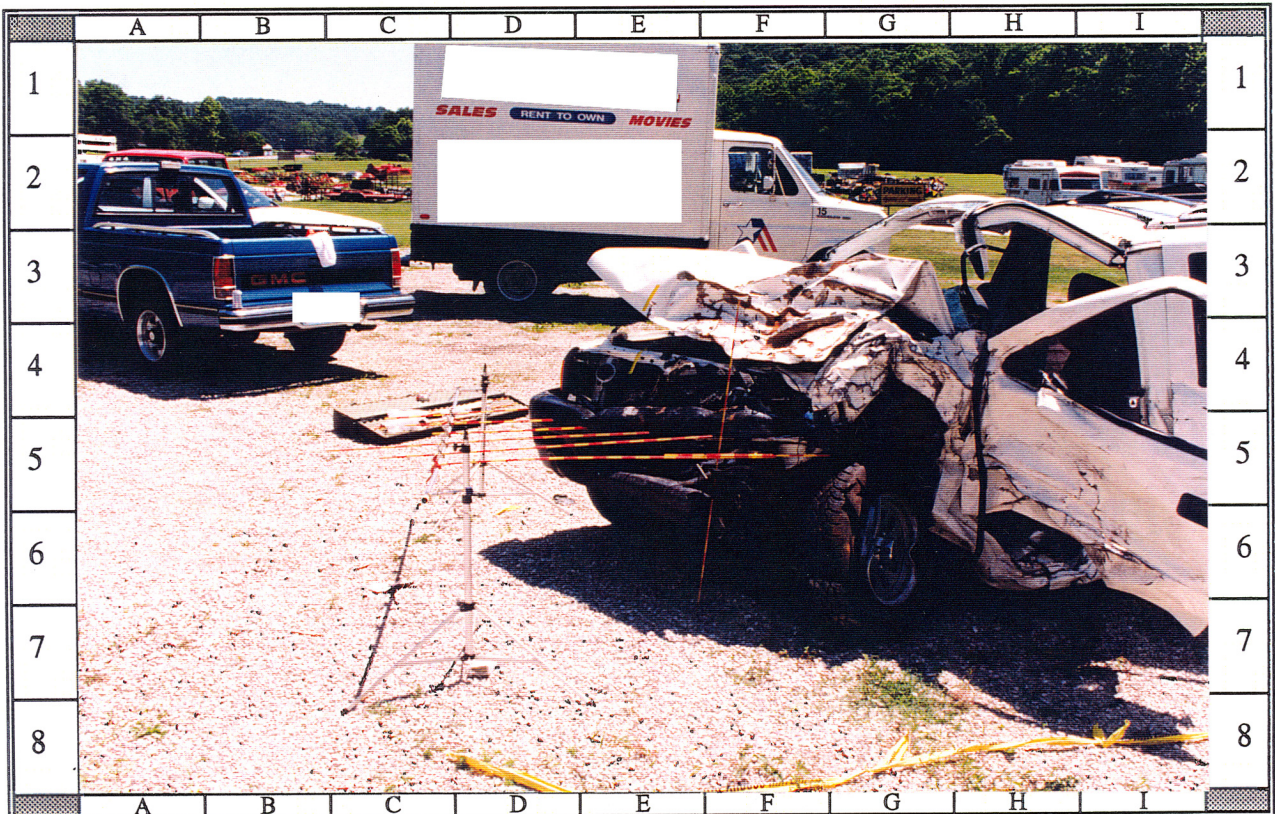
29: Case Vehicle's front left damage viewed from approximately 45 degrees left of front; NOTE: extensive crush and buckling of left front door sill

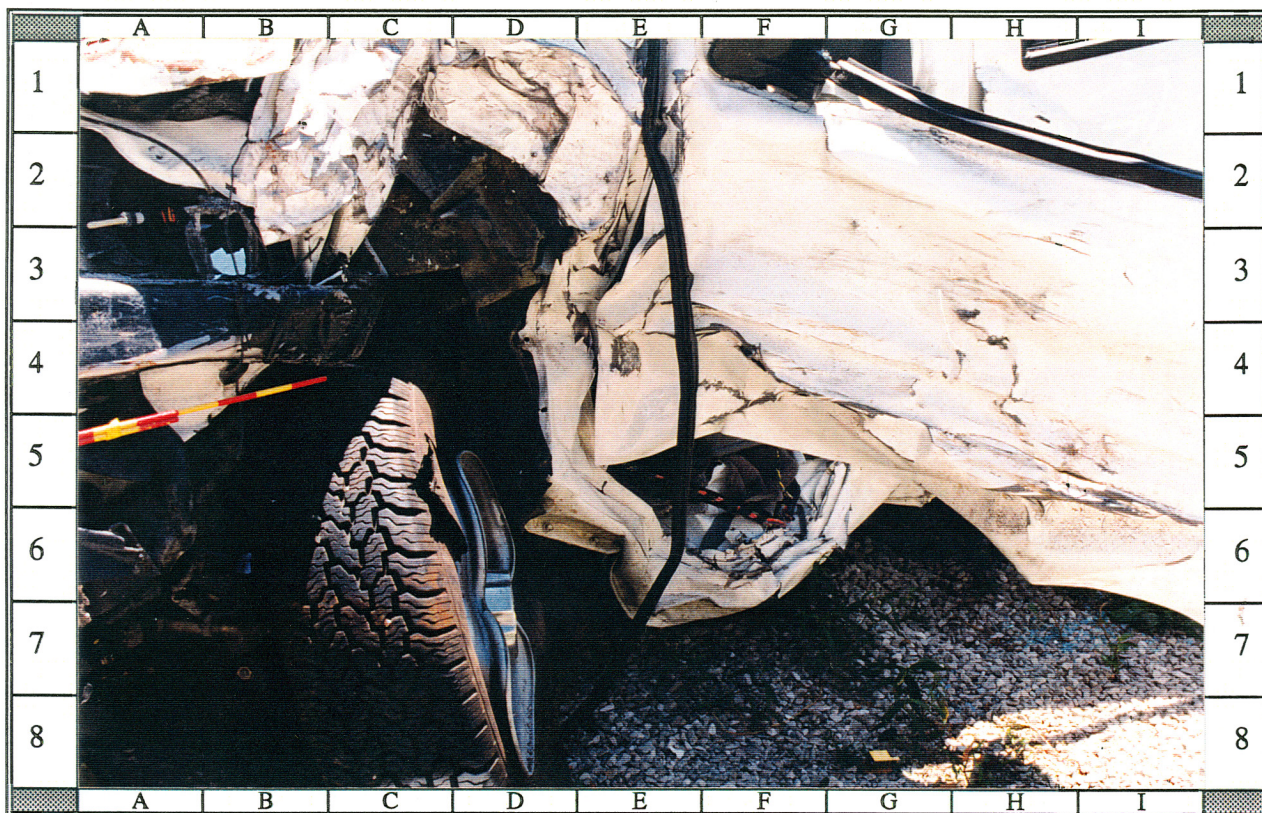
30: Reference line view of Case Vehicle's damaged front viewed from left showing extensive front left crush and direct damage to driver's door and left side rail

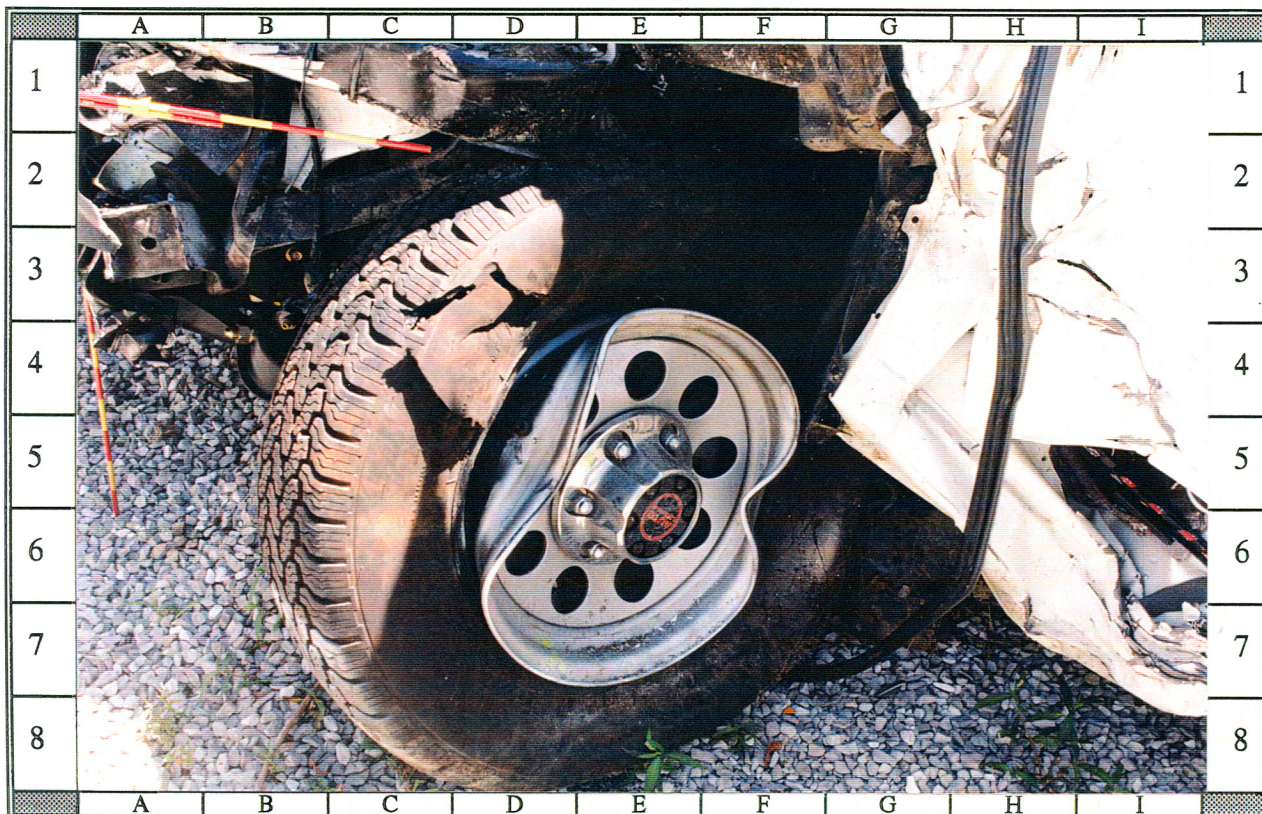
31: Close-up of Case Vehicle's left front tire and front left bumper corner; NOTE: direct damage to left front door and downward buckling to left front door sill

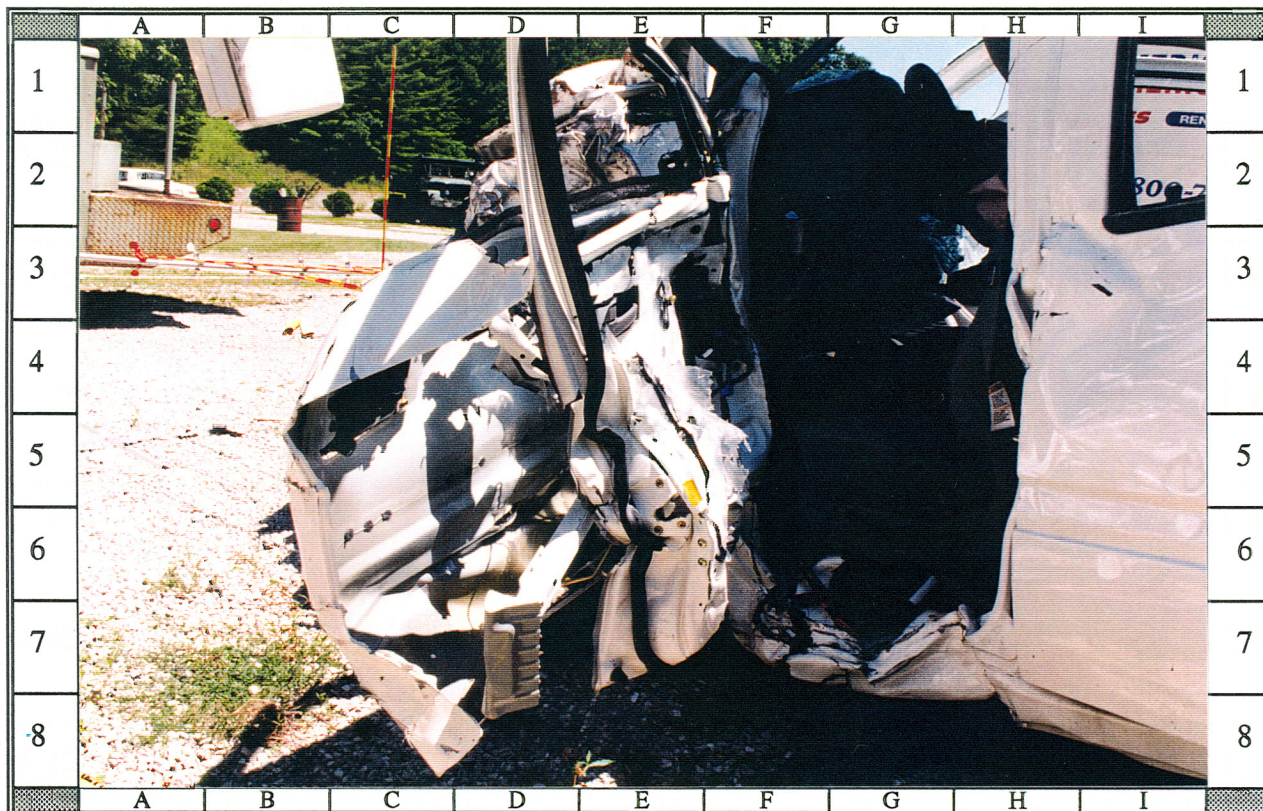
32: Close-up of Case Vehicle's damaged left front tire and wheel; NOTE: front wheel and rim damage from vehicle #2, rear damage from bottom of fire wall

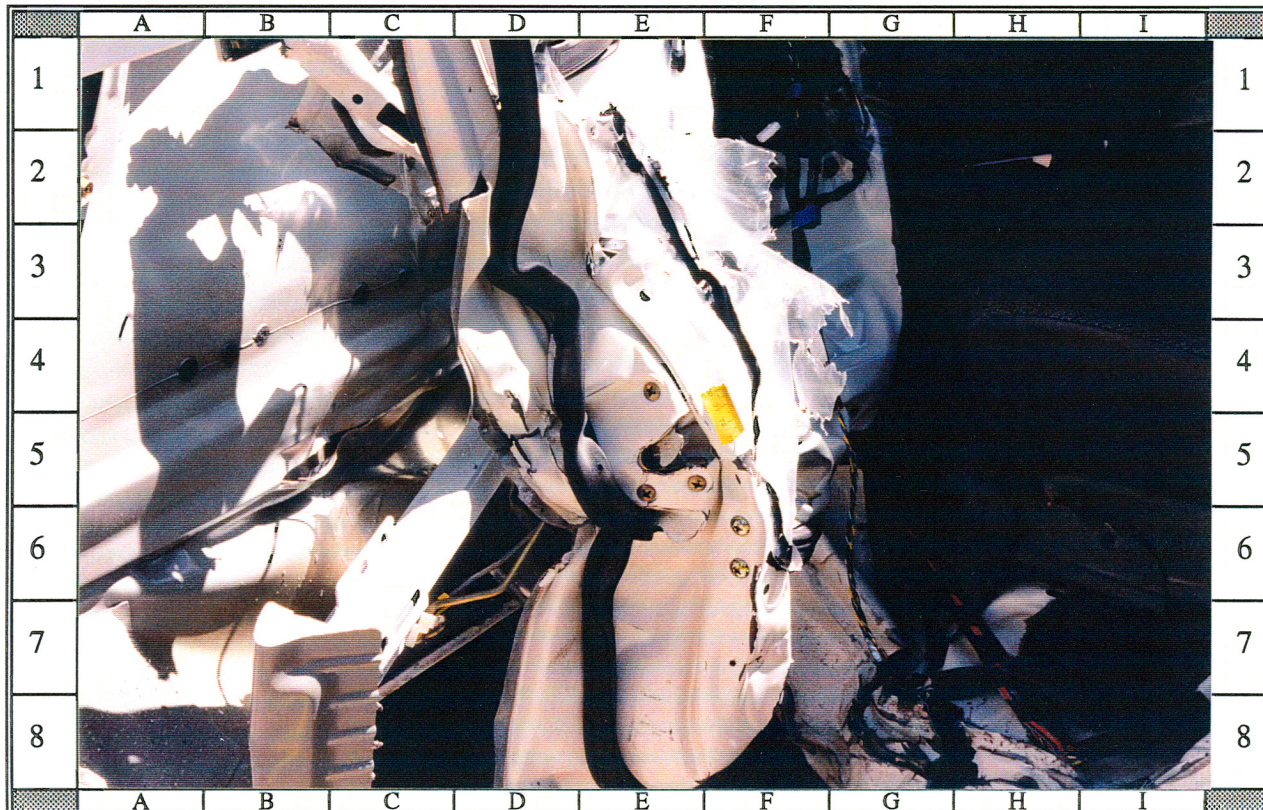
33: Case Vehicle's driver door viewed from approximately 45 degrees left of back showing separation of outer and inner door surfaces and extrication damage

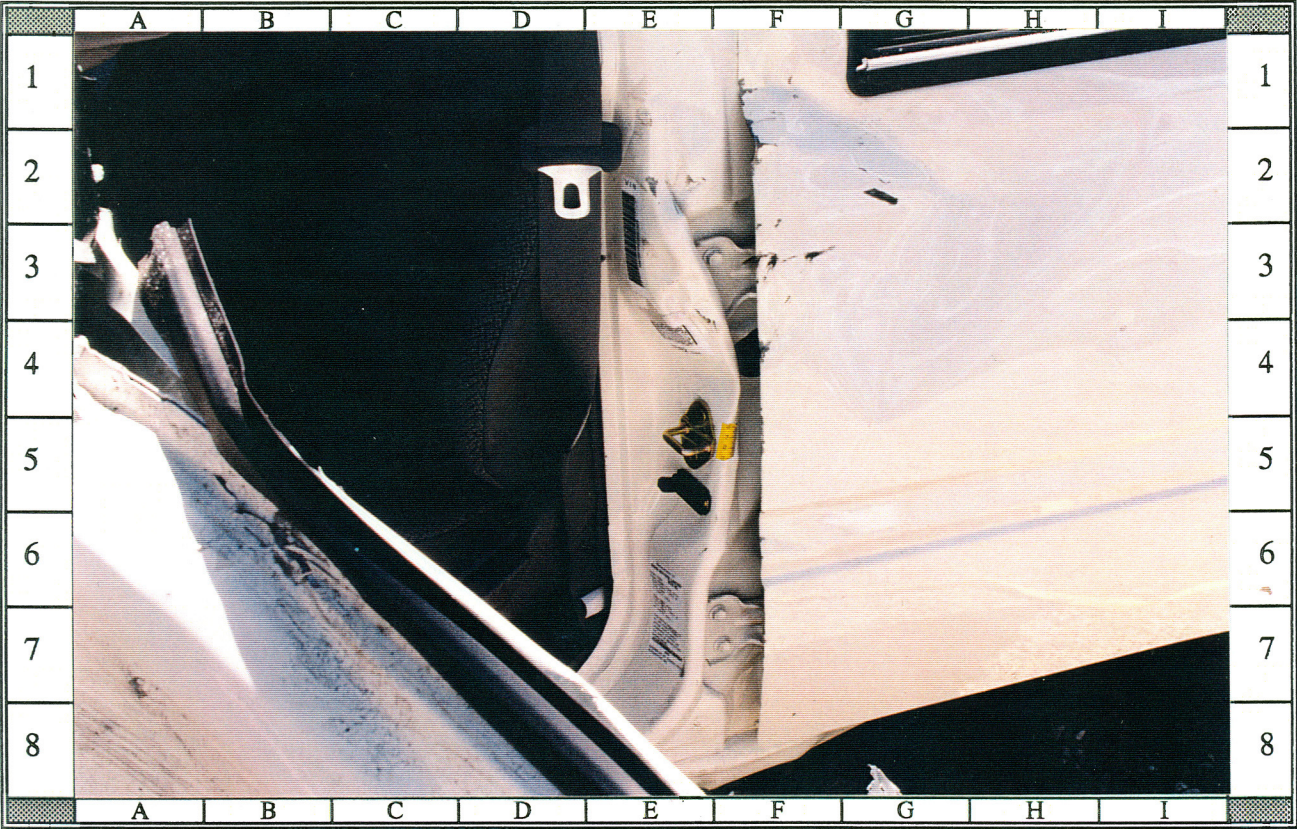
34: Close-up of rear surface of Case Vehicle's driver door; NOTE: extrication tool-induced damage and separation of outer and inner door surfaces

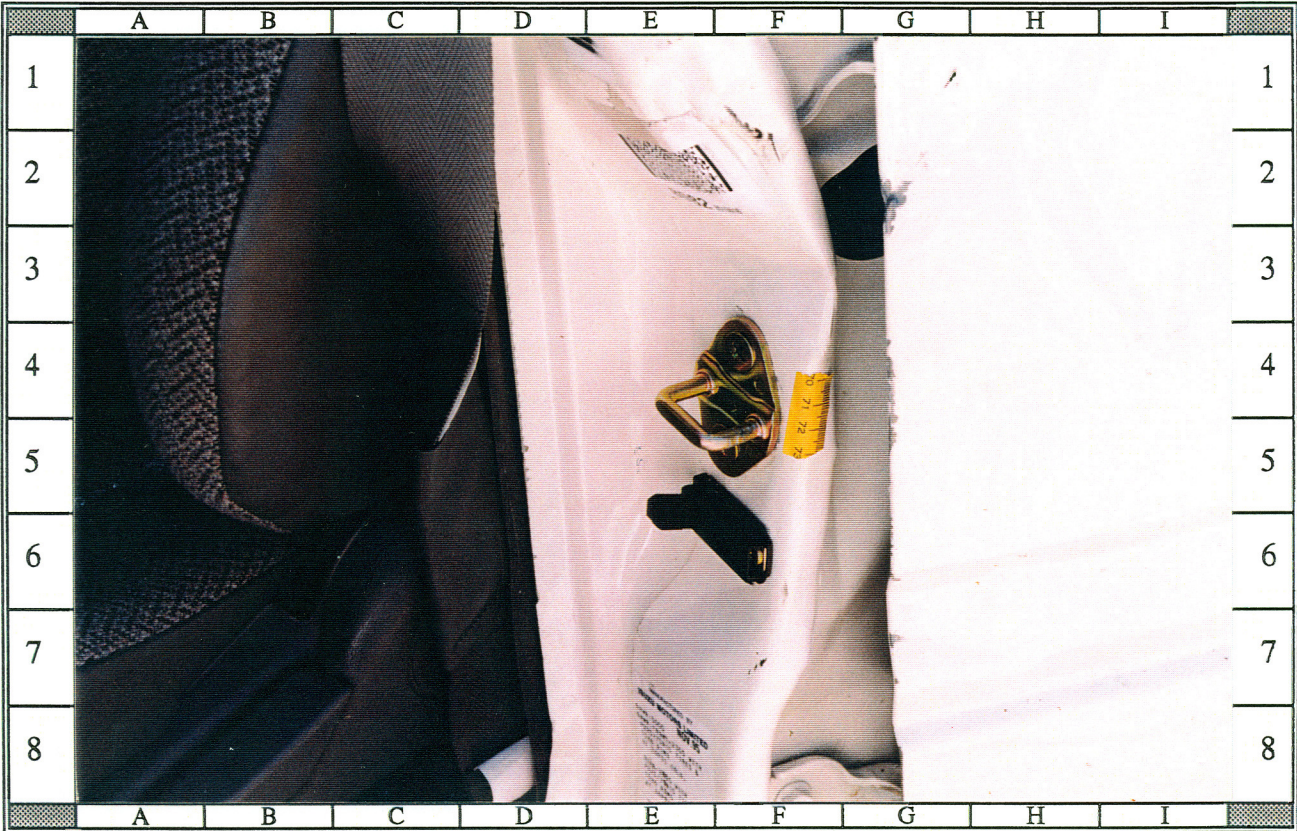
35: Latch plate for Case Vehicle’s driver door showing lack of crash-induced deformation (at yellow tape) and extrication marks on left rear door’s surface

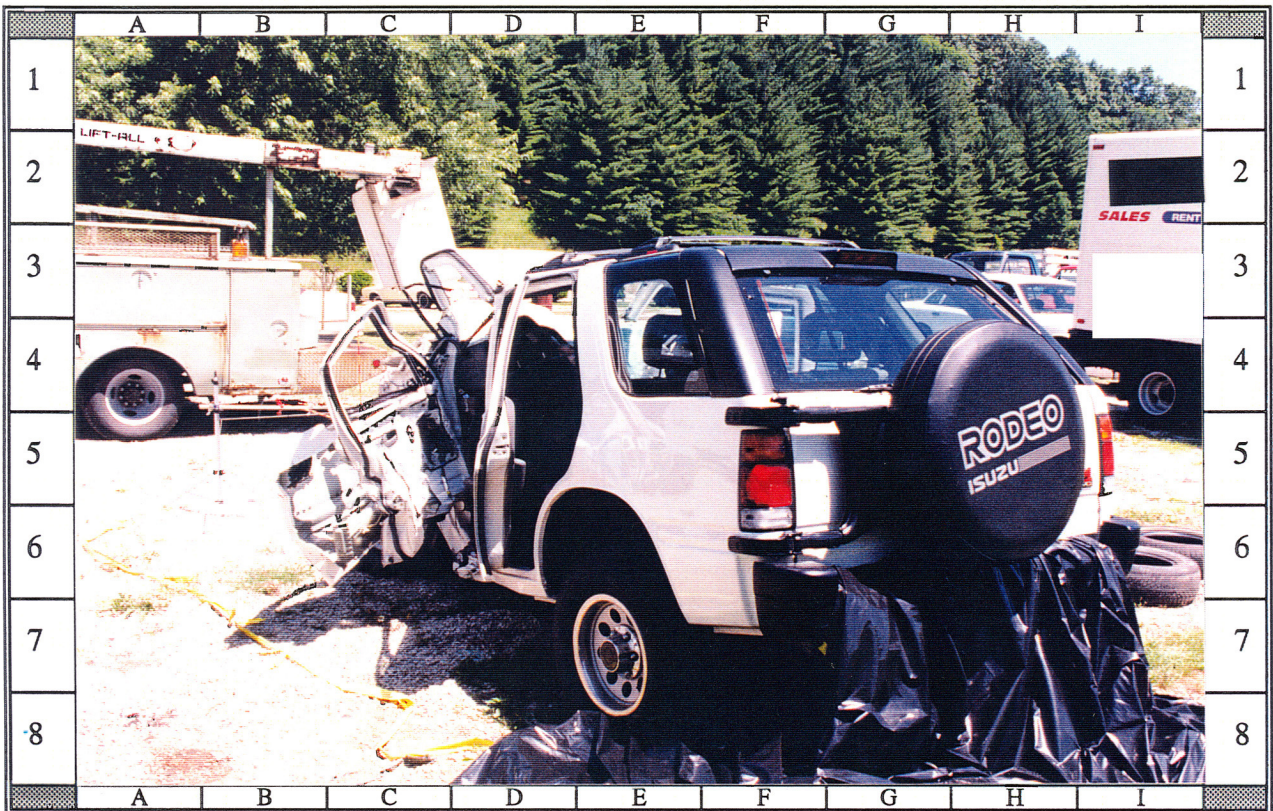
37: Case vehicle's left side and undamaged rear viewed from approximately 45 degrees left of back; NOTE: intact glazing rearward of left rear window

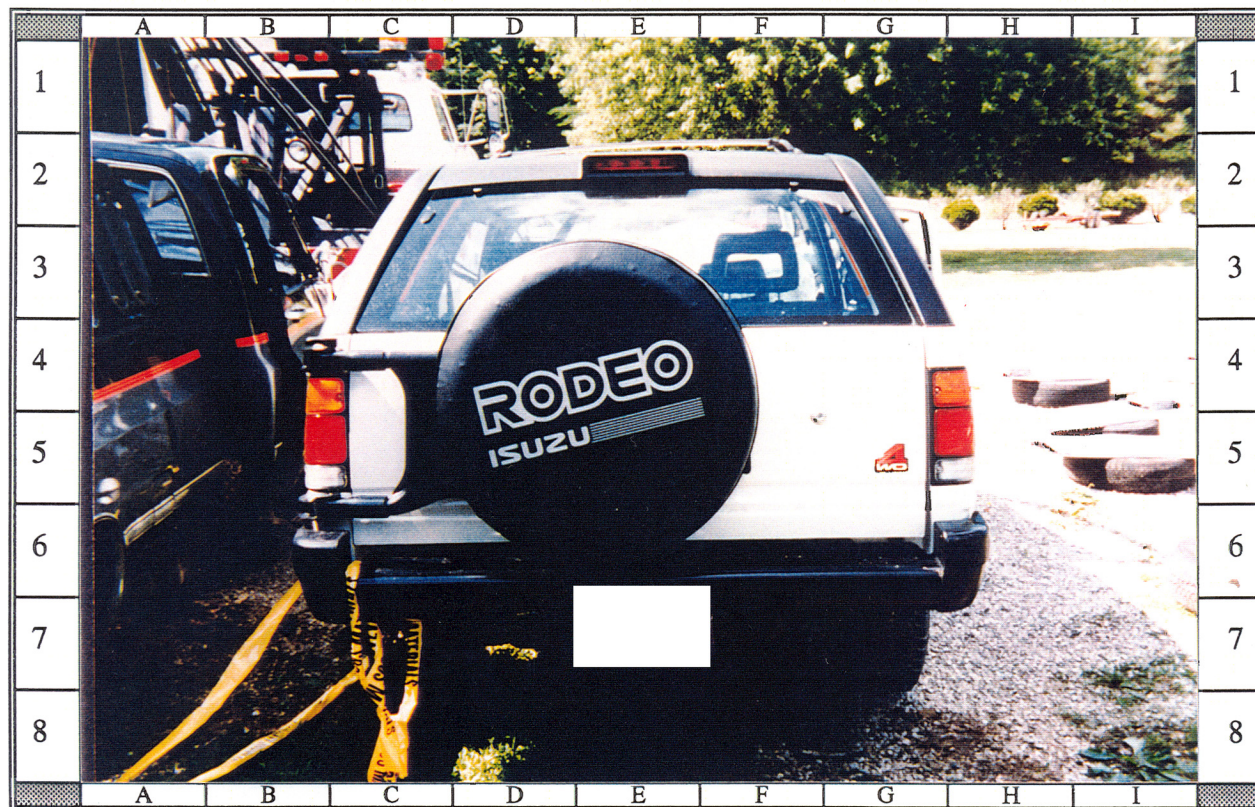
39: Case Vehicle's undamaged back plane showing four-wheel drive indicator and undamaged backlight

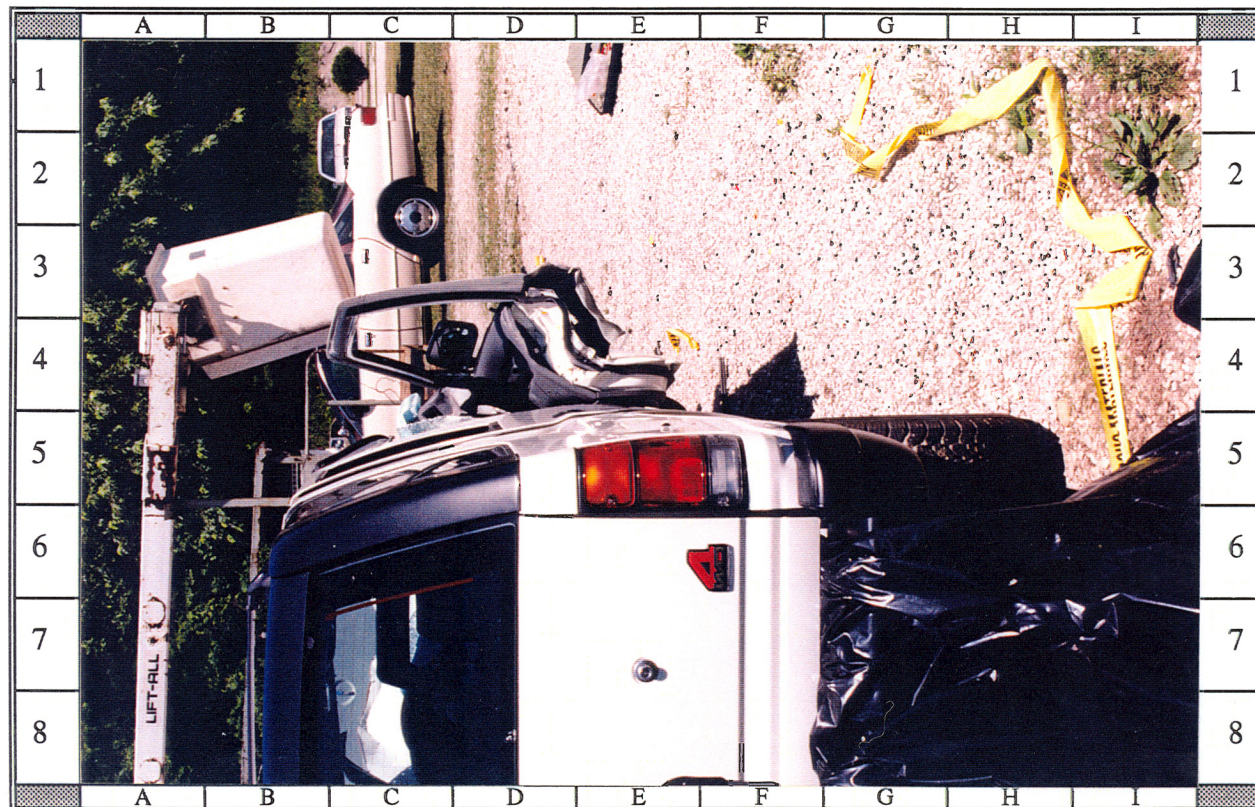
40: Reference line view of Case Vehicle's right side from back; NOTE: extrication tool-induced deformation to right front passenger door

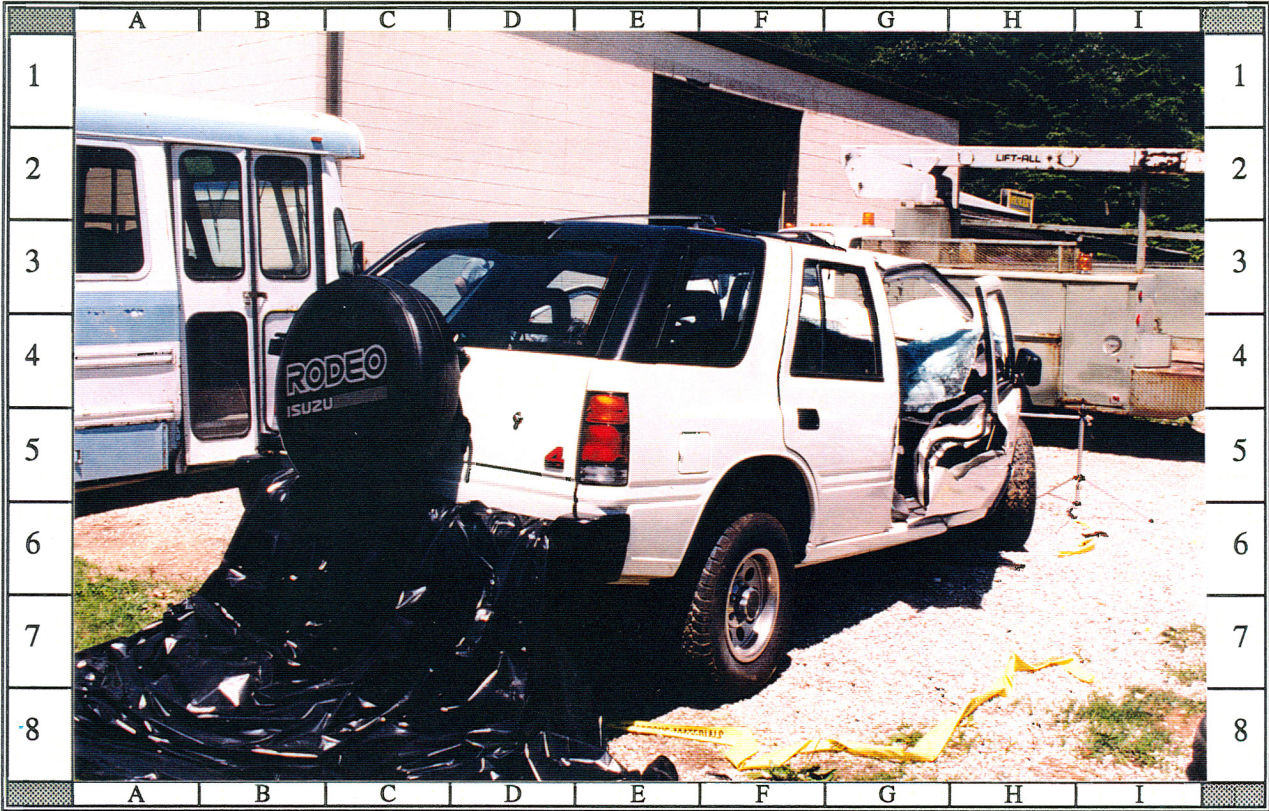
41: Case Vehicle's right side and undamaged back viewed from approximately 45 degrees right of back; NOTE: intact glazing rearward of right front window

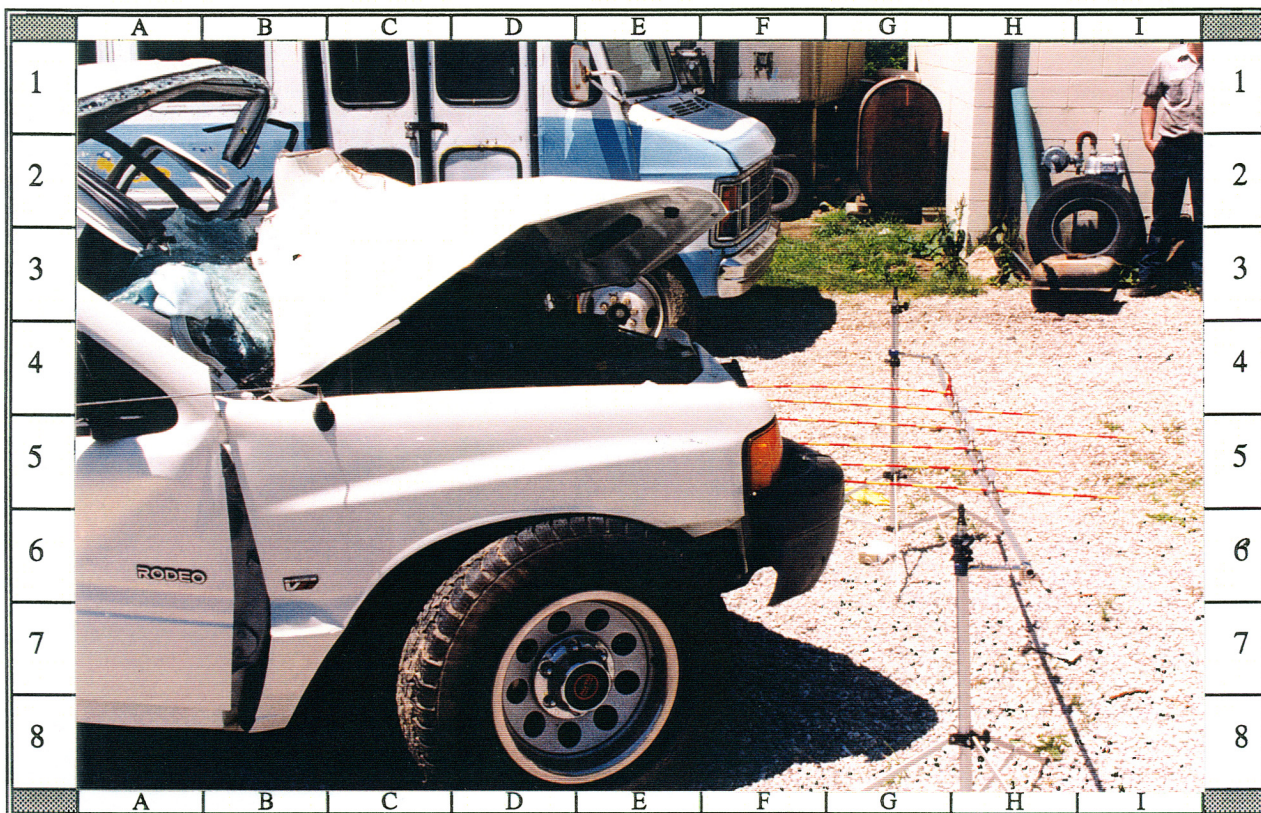
42: Close-up of Case Vehicle's lower right "B"-pillar; NOTE: extrication tool-induced damage to forward edge of right rear door and the lower "B"-pillar

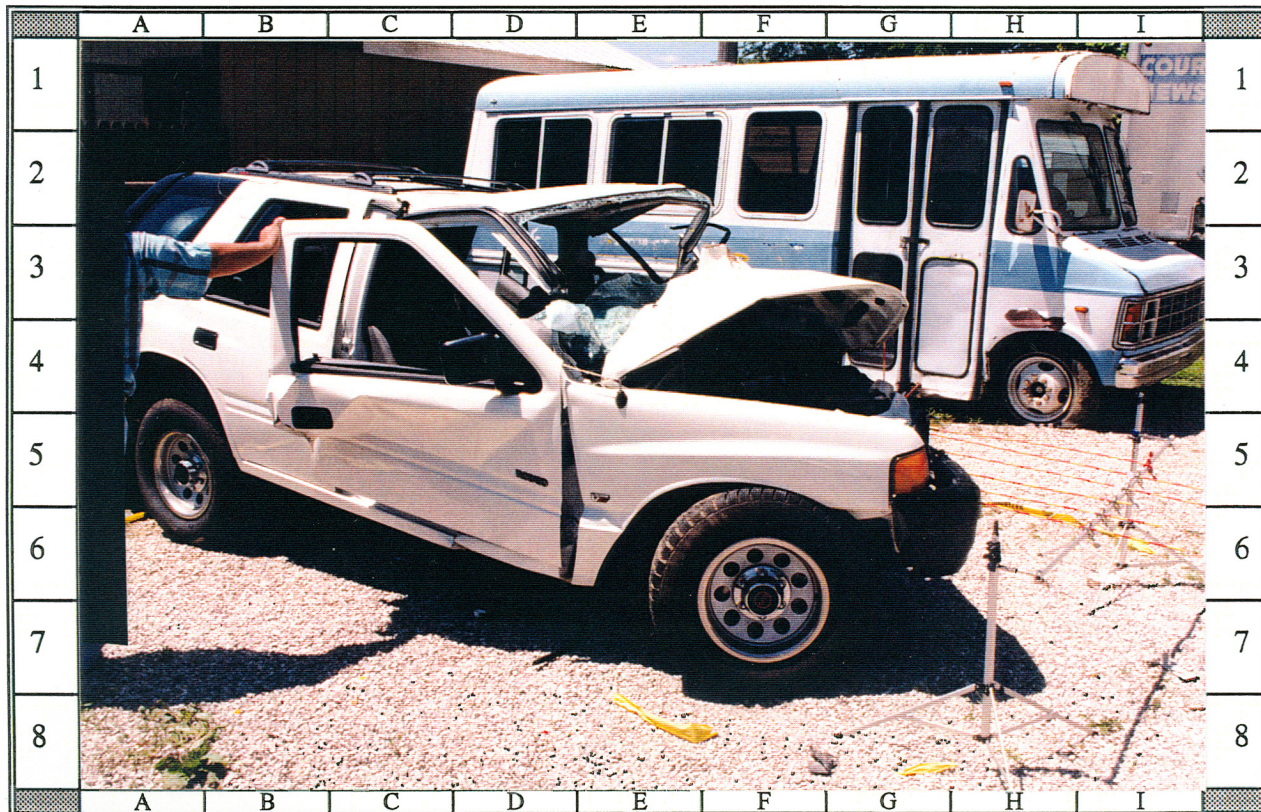
43: Reference line view of Case Vehicle's damaged front viewed from right; NOTE: leftward front end shift exposes lower right "A"-pillar area

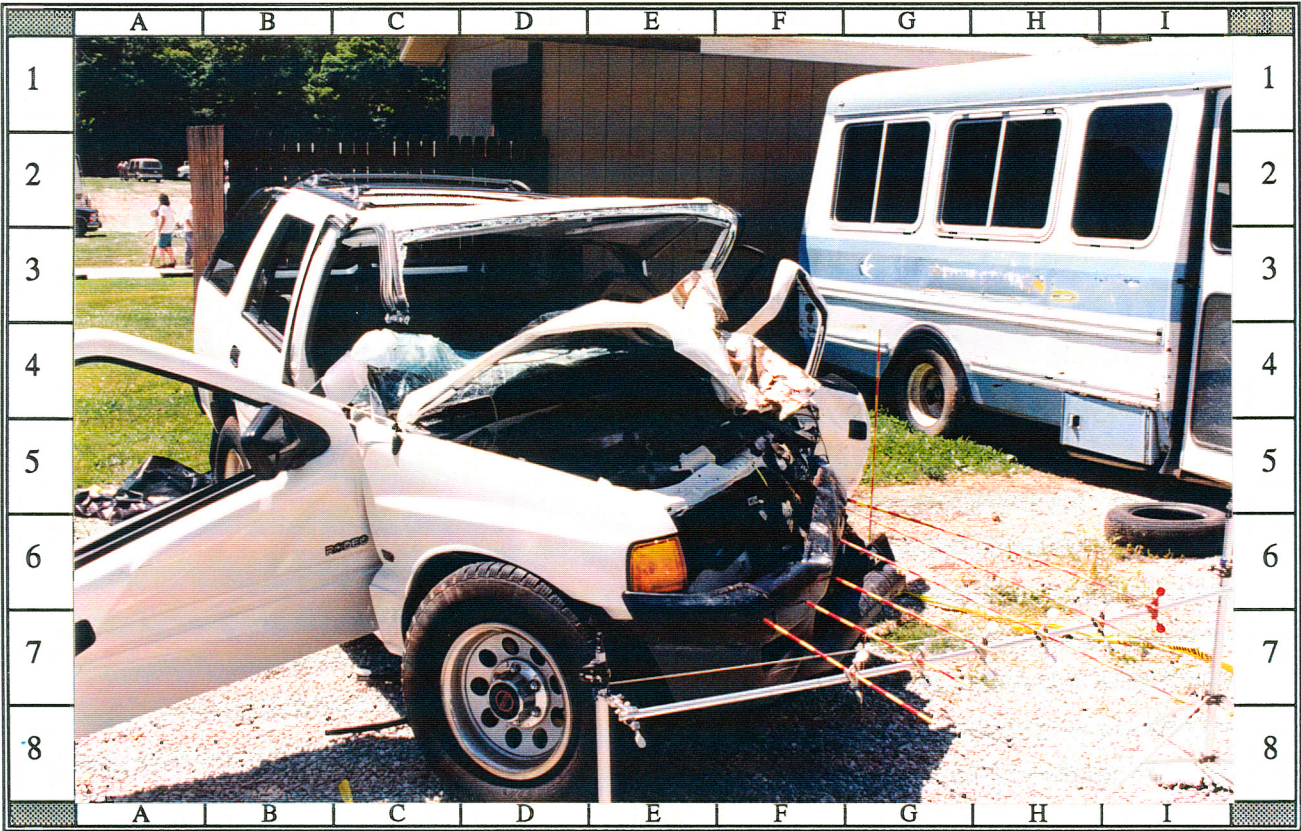
44: Case Vehicle's right side viewed from approximately 60 degrees right of front showing extrication tool-induced damage to right "A"-pillar at beltline

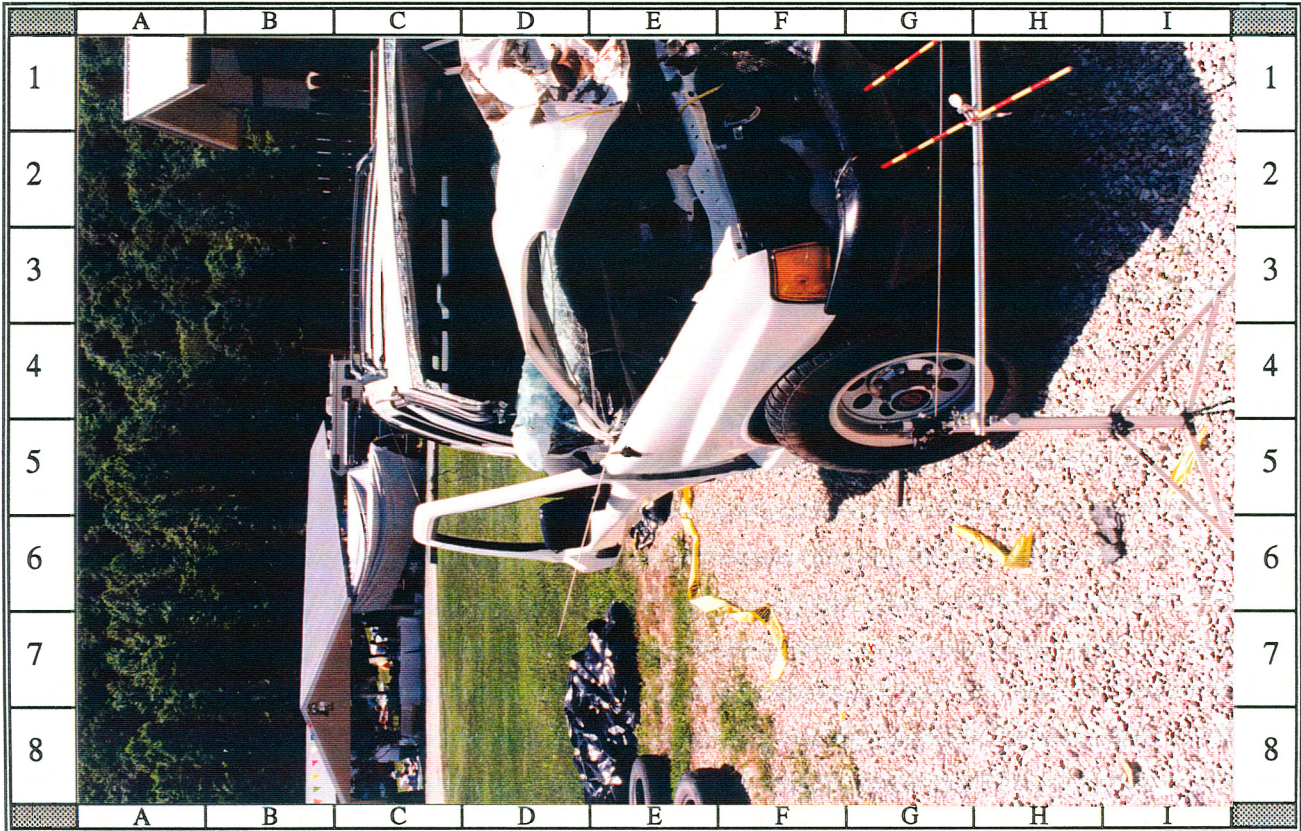
45: Case Vehicle’s frontal damage with contour gauge present viewed from approximately 15 degrees right of front showing pronounced leftward front end shift

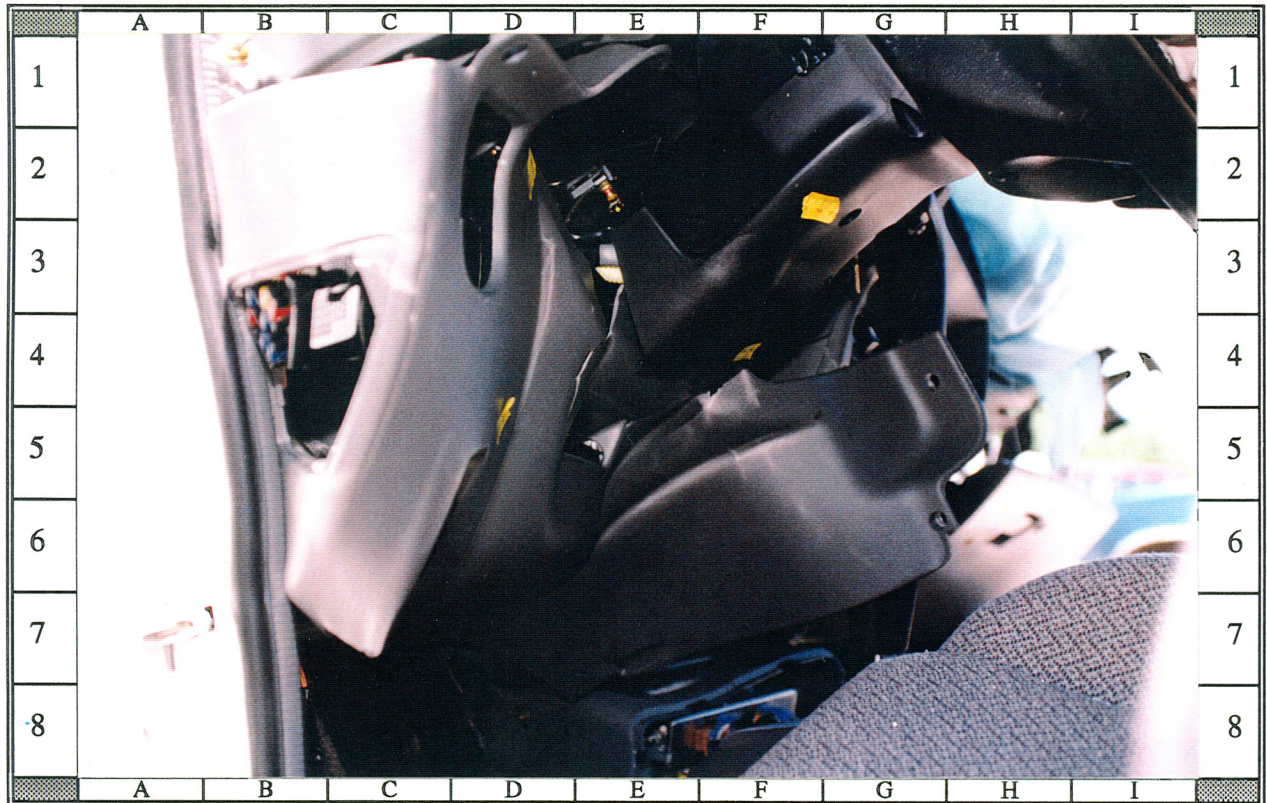
49: Close-up of Case Vehicle's left lower dash showing dash's rearward displacement and probable occupant contact points to lower dash and steering column

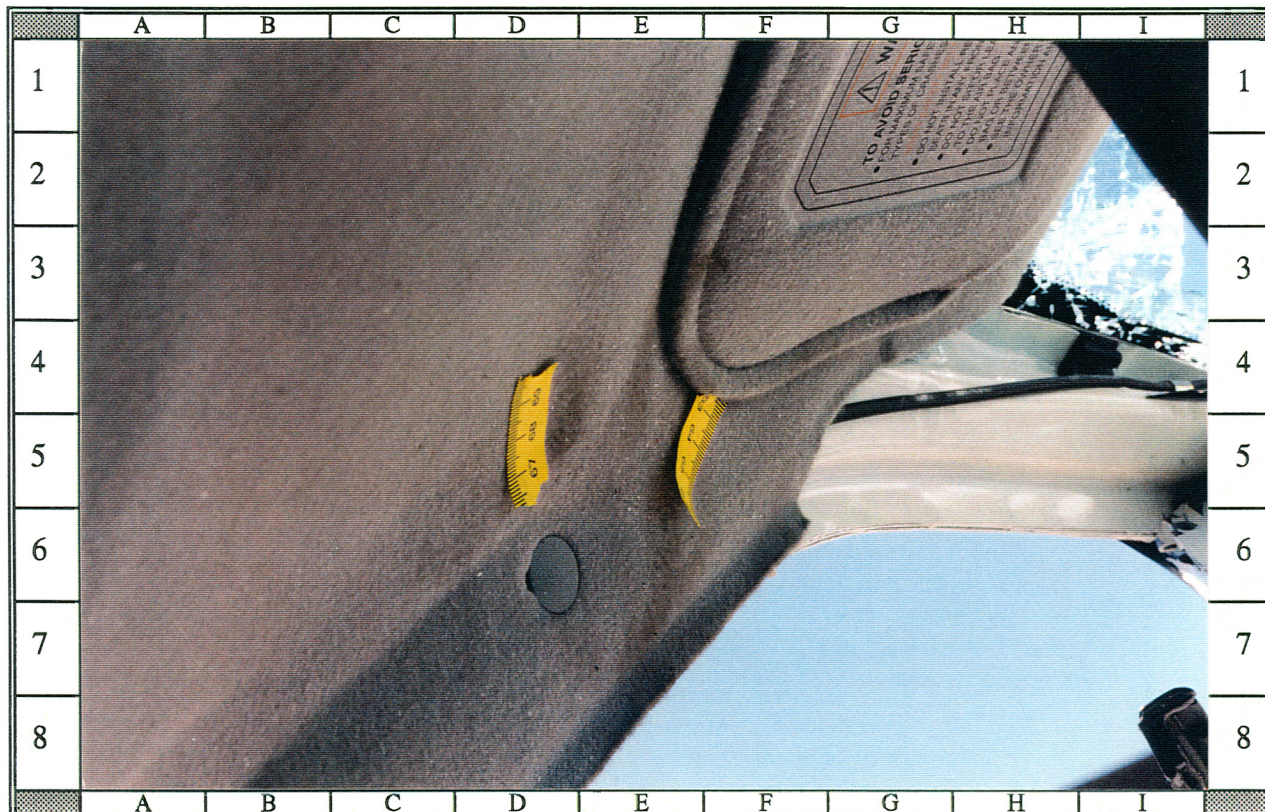
51: Case Vehicle's left upper "A"-pillar, roof header, and roof side rail; NOTE: roof hole (cells B7--B8) caused by bending roof rearward after "A"-pillars were cut

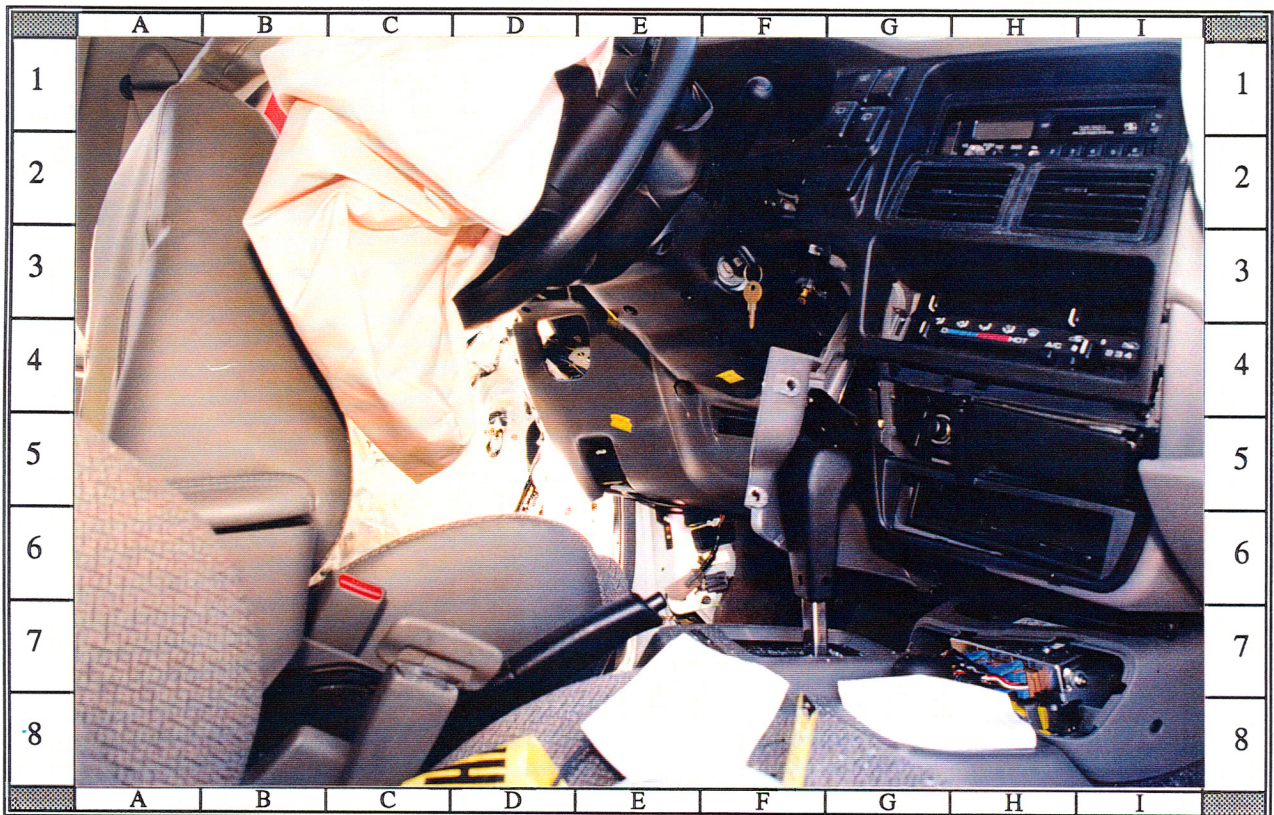
53: Close-up of Case Vehicle's lower left and center dash showing intrusion, deployed driver's air bag, and right front passenger's seat belt latch assembly

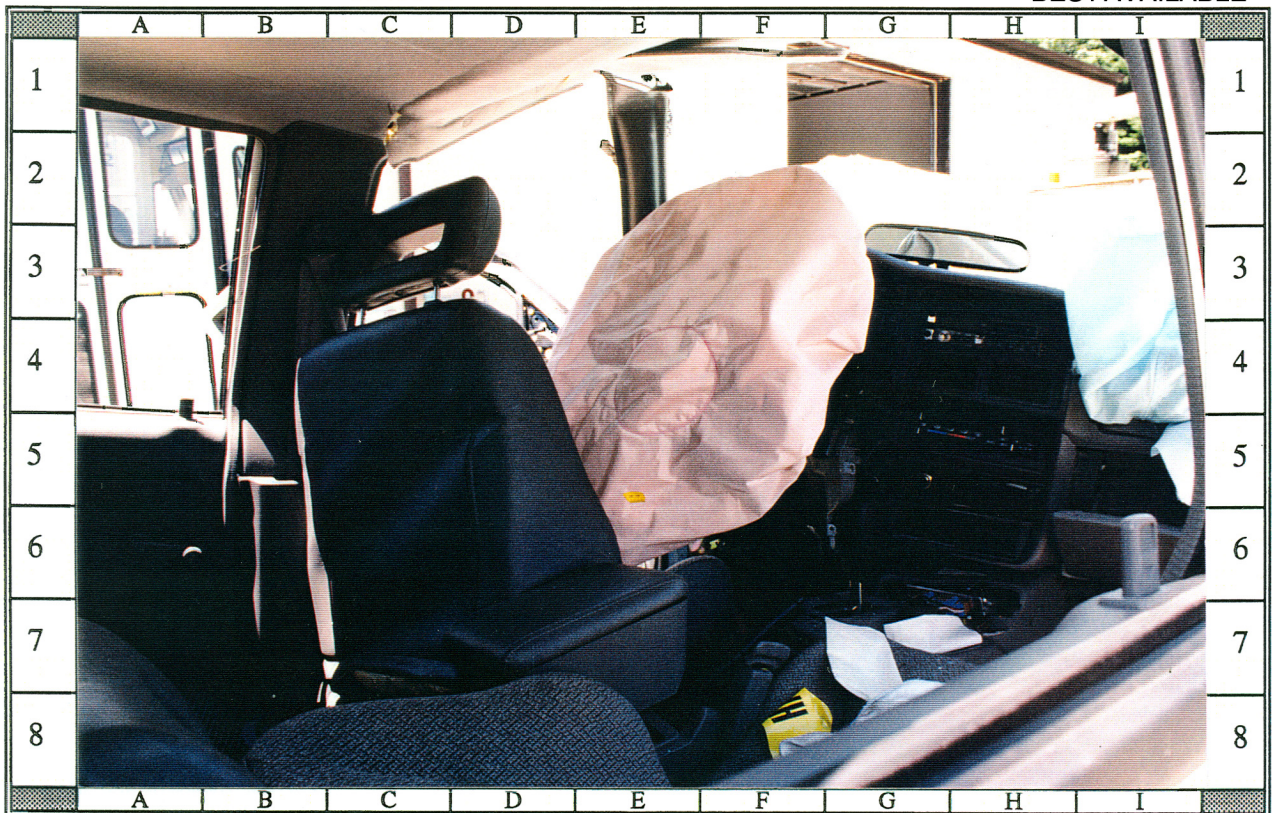
55: Case Vehicle's driver seating area viewed from the right rear; NOTE: front out-board 3-point safety belts, adjustable head restraints, and leftward tilted seatback

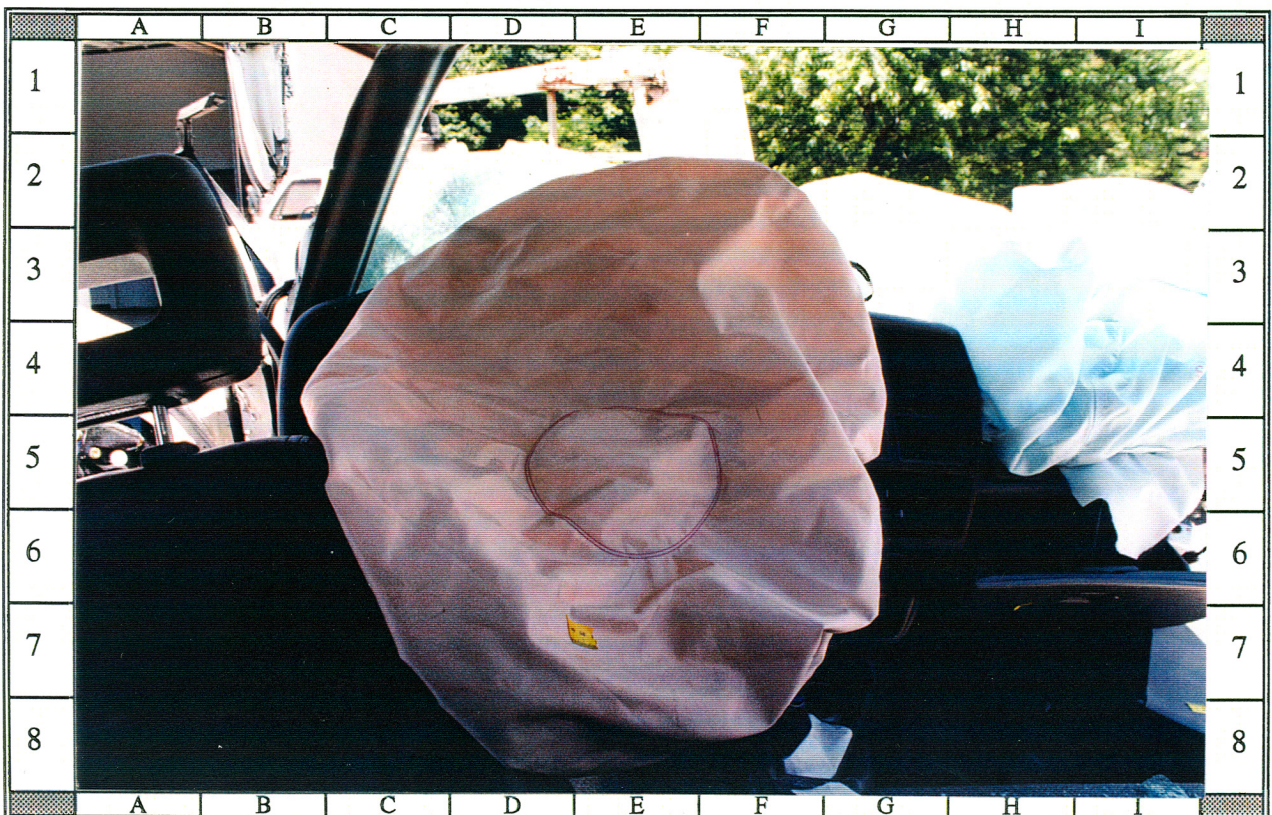
56: Case Vehicle's deployed driver air bag showing possible occupant contact point in lower center of air bag; NOTE: leftward tilting driver's seat
